Bathing Water Profile

Ballyholme

May 2019

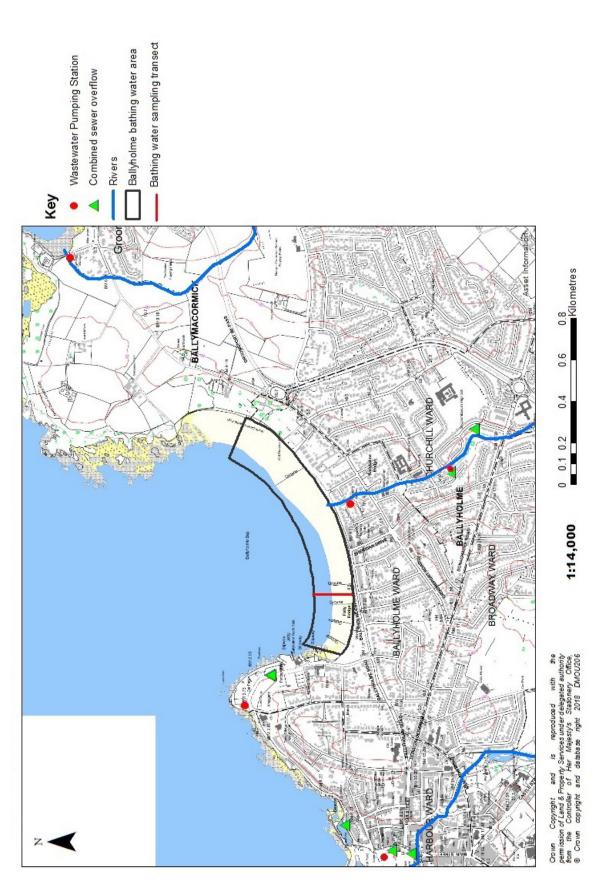
Ballyholme Bathing Water -Potential Pollution Sources

why there is general advice not to bathe during or up to 2 days after such rain. The municipal collection and treatment of waste water has the potential to cause pollution because all combined collection systems must be designed to overflow in periods of extreme wet weather or following failure of the system. If systems are not designed in that way, then sewers may overflow into residential areas. Within the area there are combined sewer overflows (CSO), emergency overflows and wastewater pumping stations with associated emergency overflows as shown on Map 1.

There are no treated waste water outfalls and waste water treatment works located in the immediate vicinity of Ballyholme bathing water (Map 1). Waste water from the wider Bangor area is pumped to a major waste water treatment facility between Bangor and Donaghadee. It provides secondary treatment with UV disinfection during the bathing season. The treated effluent is discharged some 600m offshore, to the north east of Brigg's Rocks. This is approximately 4.5km north east of the Ballyholme bathing water. A programme of improvement work is currently underway to upgrade the sewerage infrastructure, Combined Sewer Overflows (CSOs) and Wastewater Pumping Stations (WwPSs) in the Bangor area. At an estimated £12 million total investment by NI Water, the project aims to provide greater protection of the water quality in Ballyholme.
