Bathing Water Profile

Ballywalter

May 2019

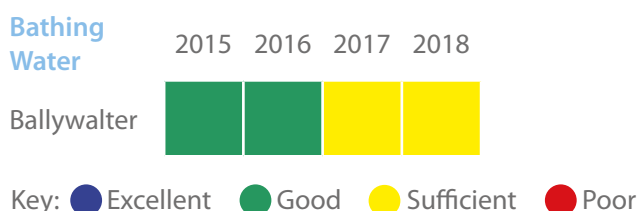
Ballywalter Bathing Water Quality 2015-2018

In 2015 the 1976 Bathing Water Directive was replaced by the European Bathing Water Directive 2006/7/EC. This revised directive introduced more stringent bathing water standards. Bathing Waters are classified as Excellent, Good, Sufficient or Poor (see above). This classification is based on a statistical assessment of results from the last four years.
