Bathing Water Profile

Carnlough

May 2019

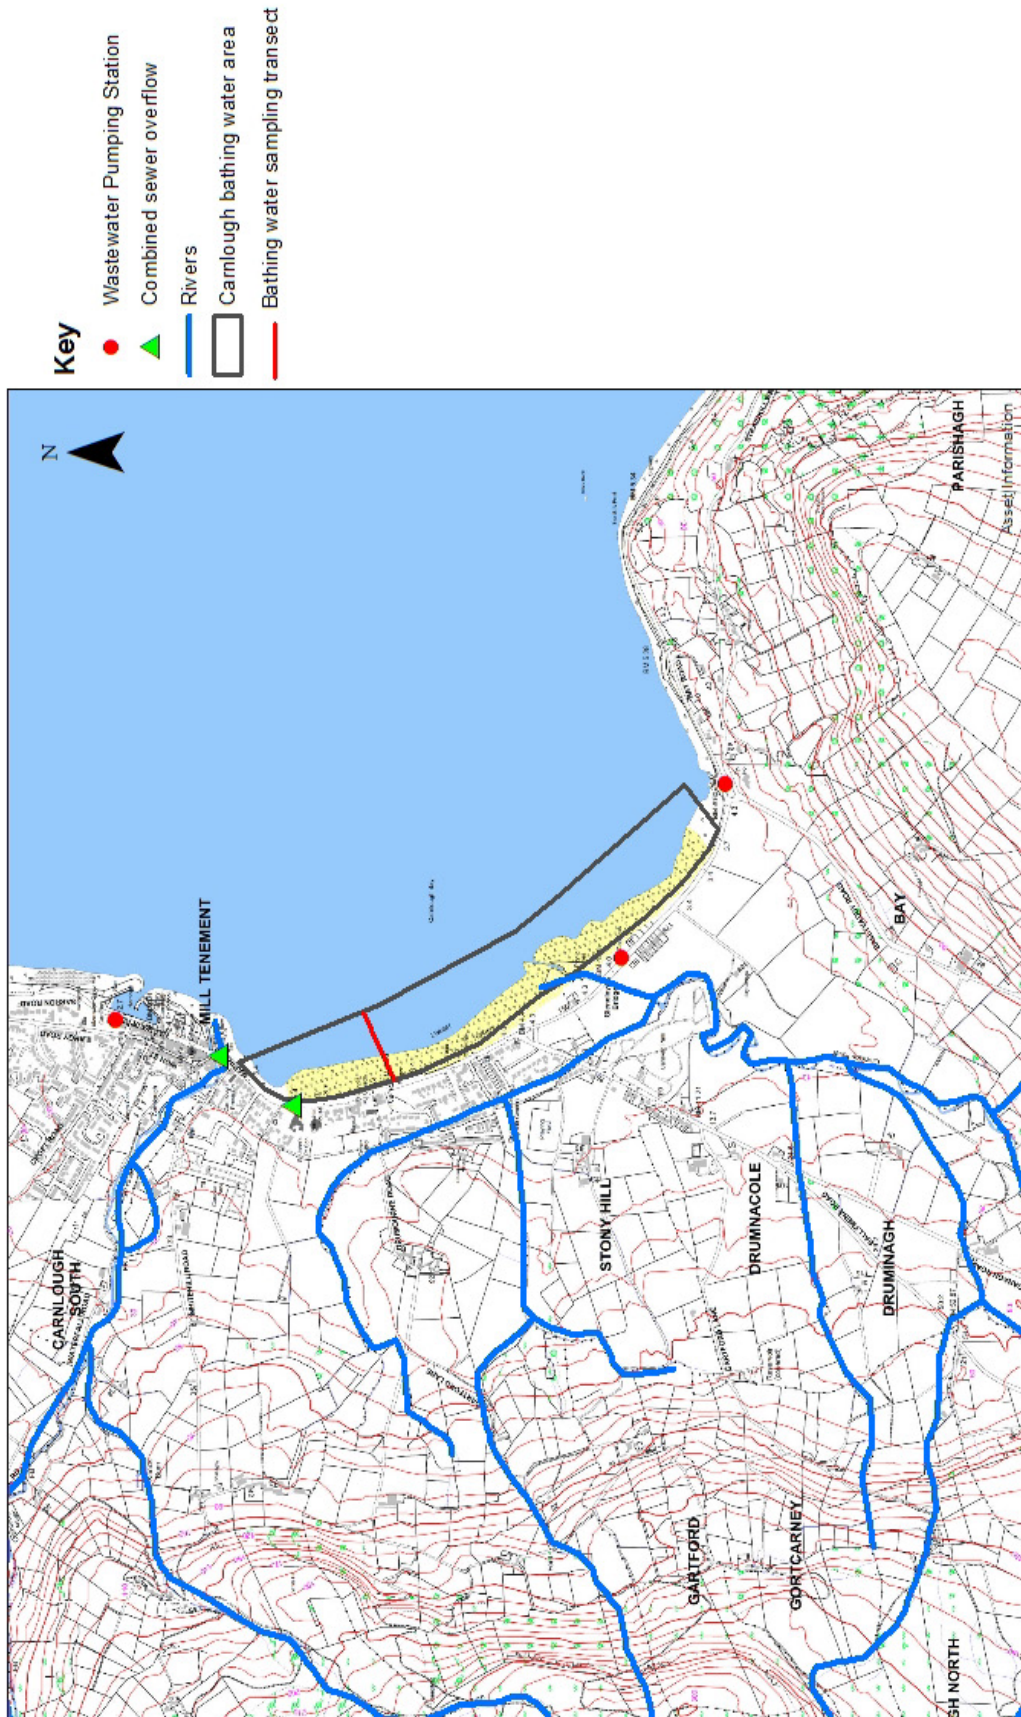
Map 1
Carnlough Bathing Water -
Potential Pollution Sources

to overflow in periods of extreme wet weather or following failure of the system. If systems are not designed in that way, then sewers may overflow into residential areas. Within Carnlough bathing area there are combined sewer overflows (CSO), emergency overflows and waste water pumping stations with associated emergency overflows as shown on Map 1.

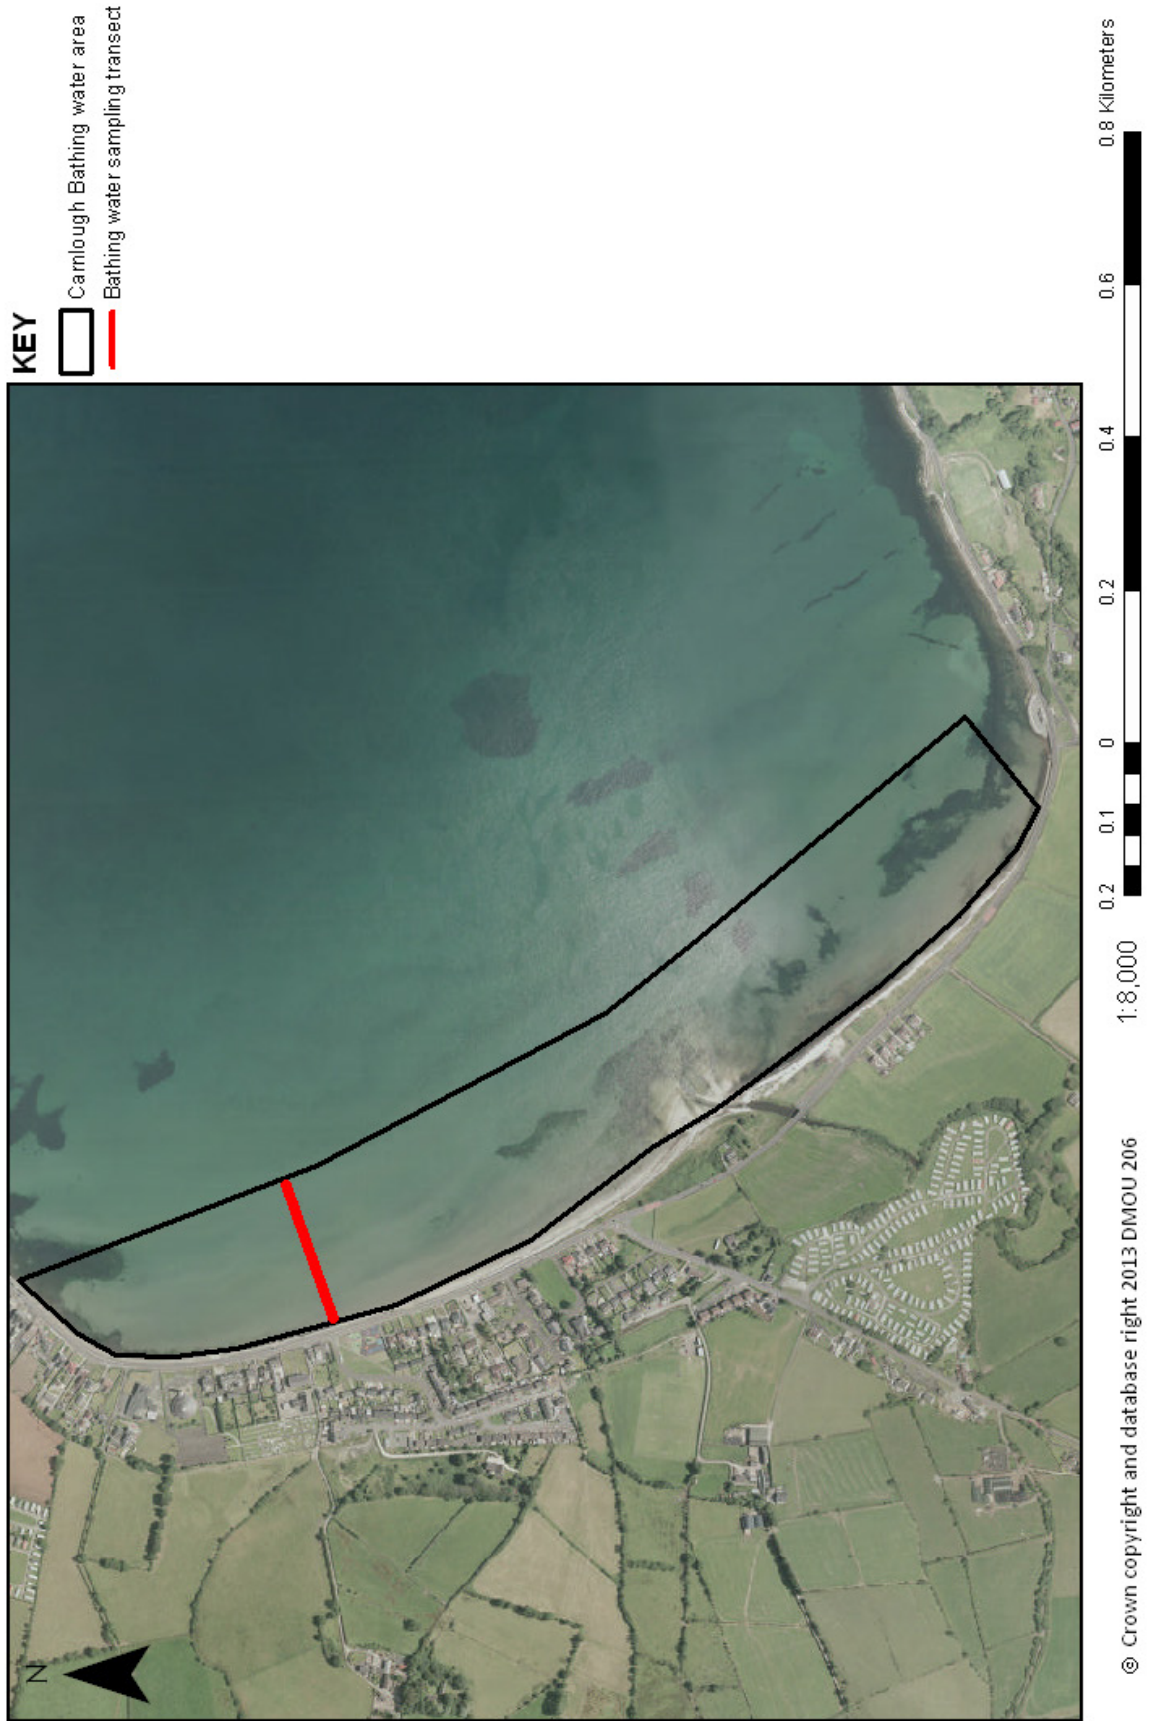
Map 2
Carnlough Bathing Water -
EC Bathing Water Sample Location

Bathing Water Name	Carnlough Bathing Water
EU bathing water ID number	UKNO5_50900
Location	UK/Northern Ireland/County Antrim/Antrim Coast
Year of identification	2006
Local council area	Mid and East Antrim Borough Council
Bathing Water Operator	Mid and East Antrim Borough Council
Description of bathing beach	Mainly sand with some rocky outcrops and pebbles, 1.5 kilometres in length.
Monitoring Point	Northern end of bathing water, D28601737 (Map 2)
