# Bathing Water Profile

## Groomsport

May 2019

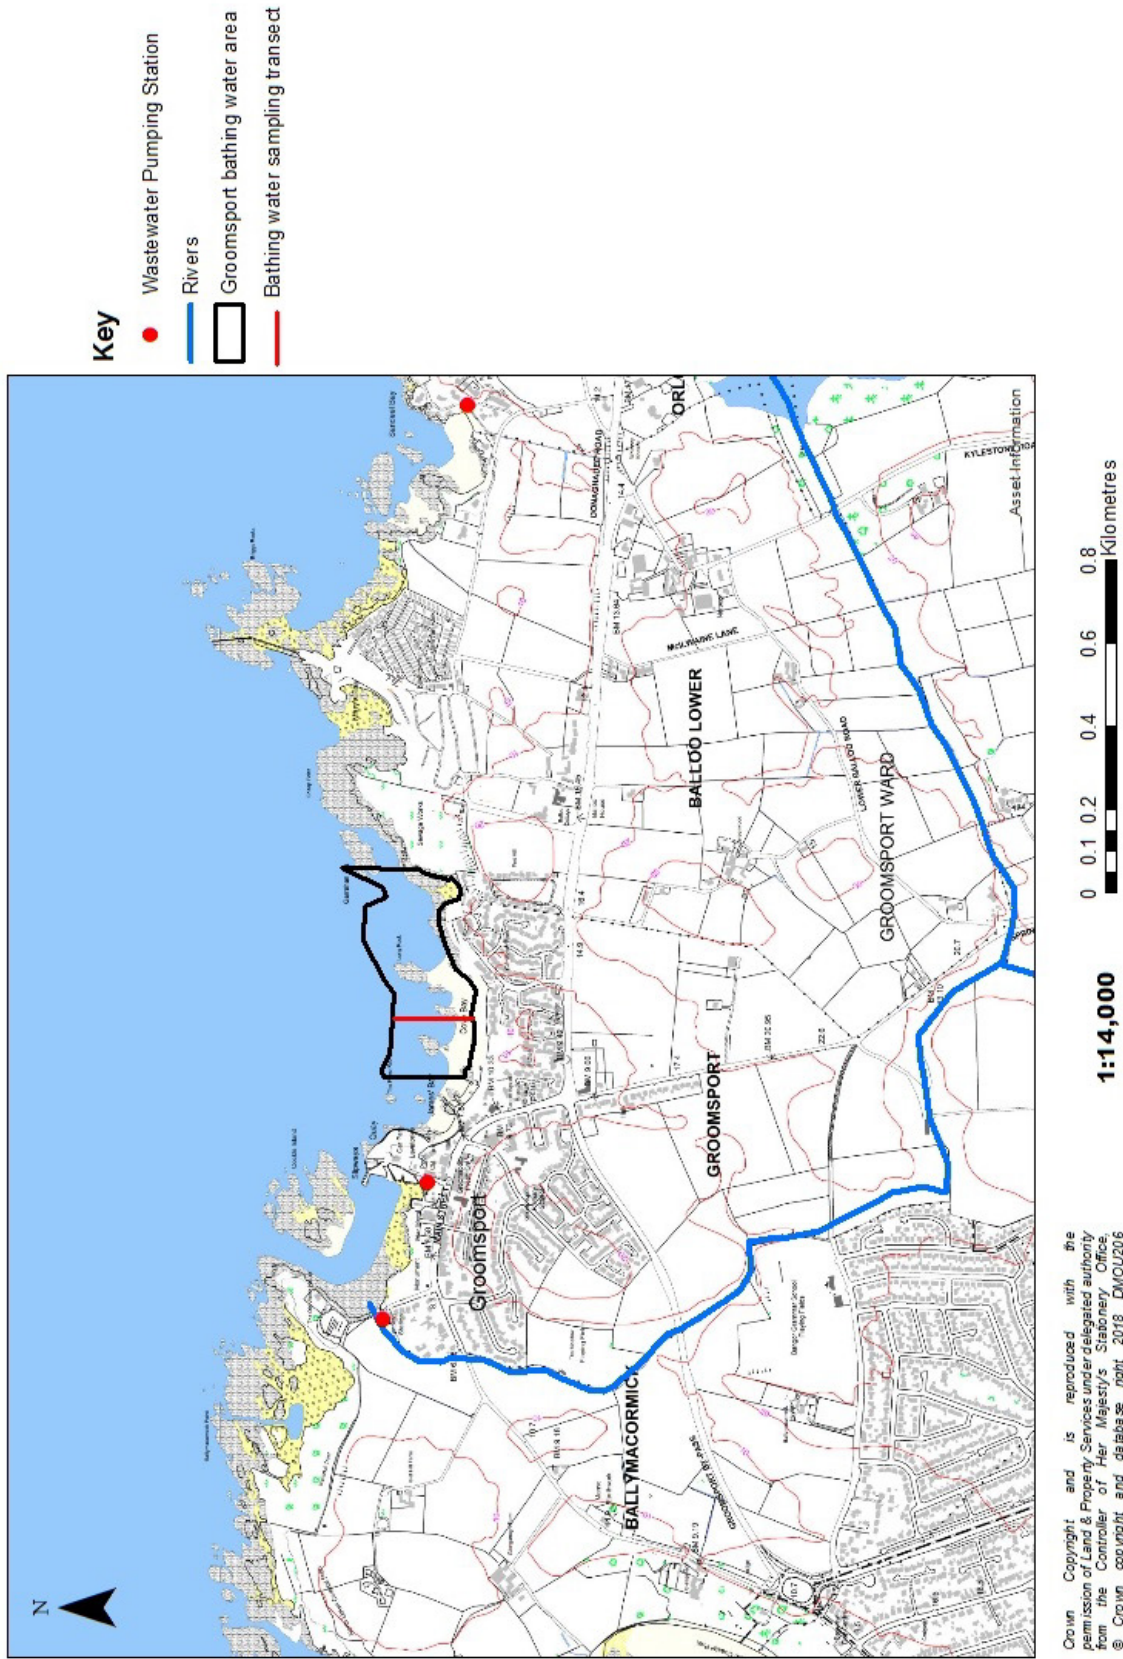
Map 1  
Groomsport Bathing Water -  
Potential Pollution Sources

The municipal collection and treatment of waste water has the potential to cause pollution because all collection systems must be designed to overflow in periods of extreme wet weather or following failure of the pump system. If systems are not designed in that way, then sewers may overflow into residential areas. Within the area there are combined sewer overflows (CSO), emergency overflows and wastewater pumping stations with associated emergency overflows as shown on Map 1.

Groomspport bathing water is located on the North Down coast. The beach is approximately 0.5 km in length and comprised of sand interspersed with rocky outcrops, a smaller sandy cove and a further rocky outcrop (Map 1). The bathing water is backed by the residential part of Groomspport village. There is a harbour to the west of the bathing water with facilities such as a boathouse, children's play park, paddling pool, car park and public toilets. This harbour area is popular as a centre for both shore based recreation and water based activities such as sailing and power boating.

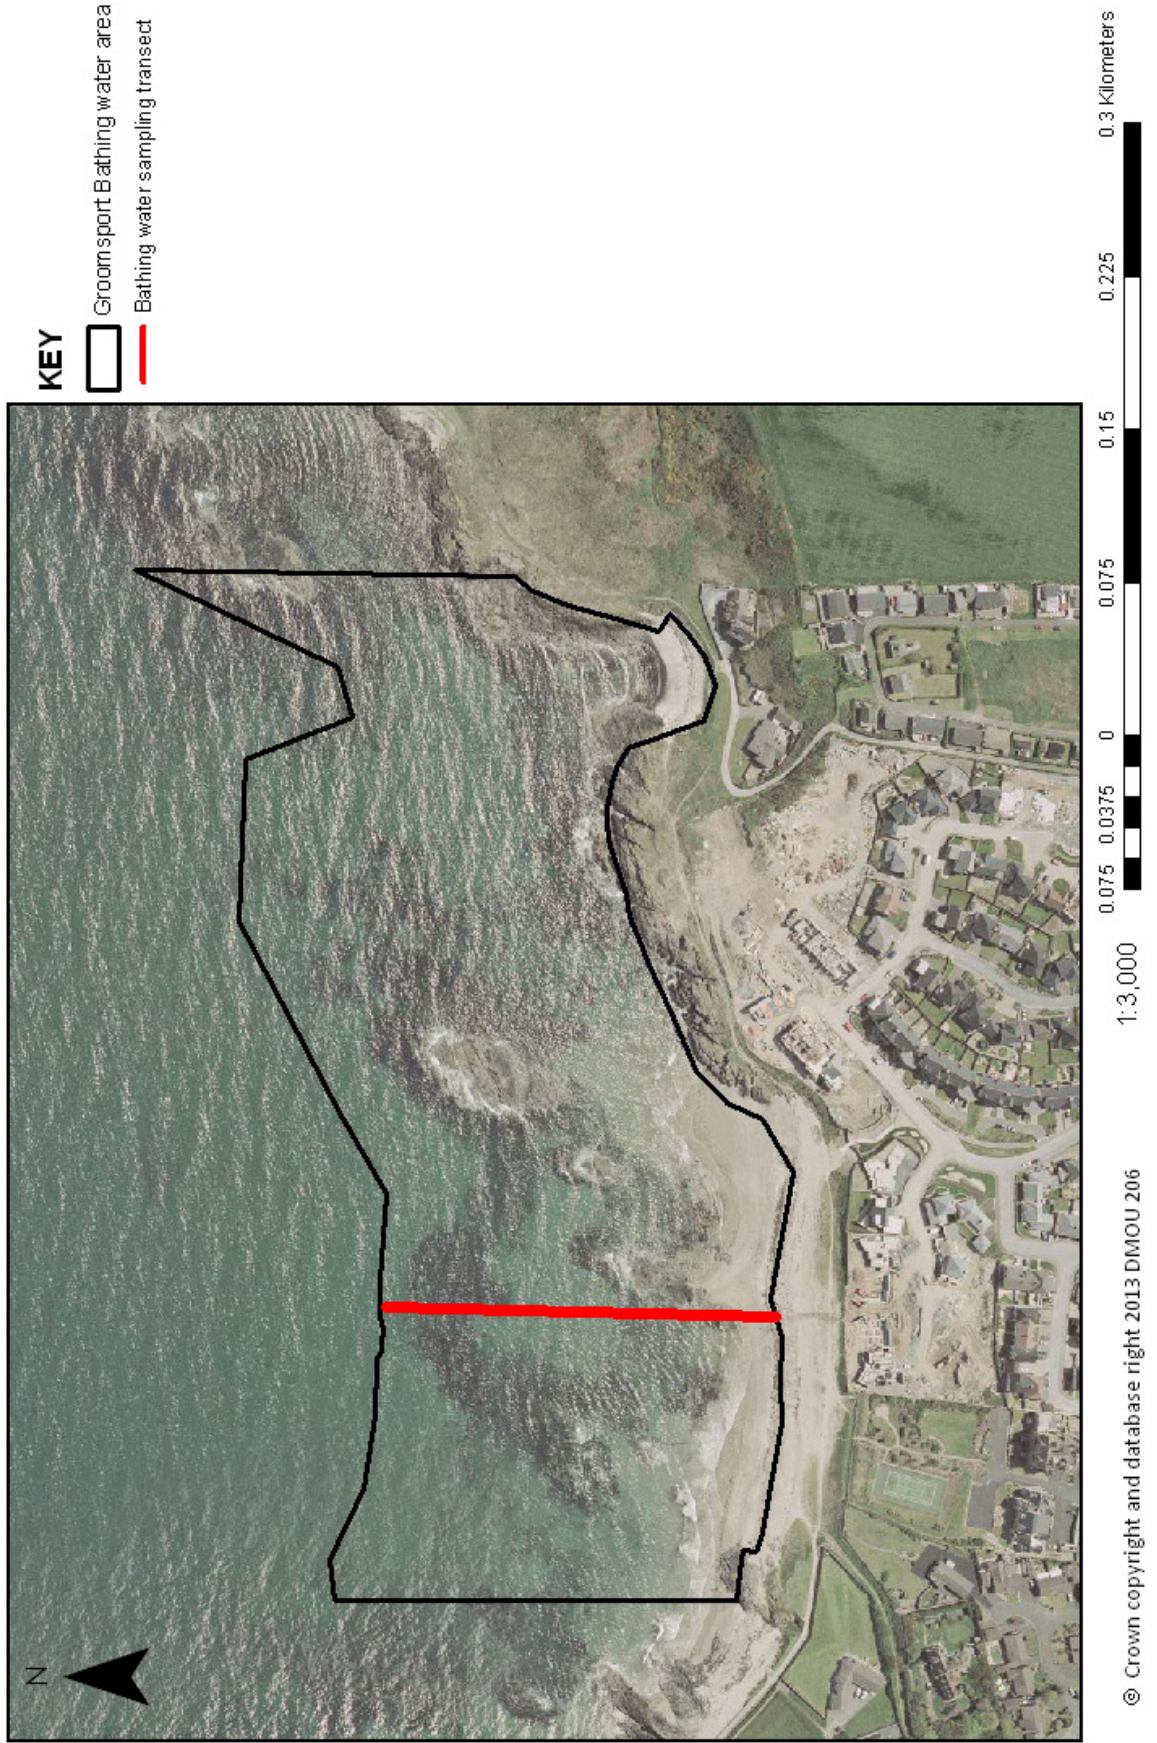
Map 2  
Groomsport Bathing Water -  
EC Bathing Water Sample Location

<b>Bathing Water Name</b>	Groomspport Bathing Water
<b>EU bathing water ID number</b>	UKNO2_52800
<b>Location</b>	UK/Northern Ireland/County Down/North Down Coast
<b>Year of identification</b>	1988
<b>Local council area</b>	Ards and North Down Borough Council
<b>Bathing Water Operator</b>	Ards and North Down Borough Council
<b>Description of bathing beach</b>	Sand, rocky outcrops, approximately 0.5 kilometres in length
<b>Monitoring Point</b>	Western end of bathing water, J54128342 (Map 2)
