Bathing Water Profile

Cranfield Bay

May 2018

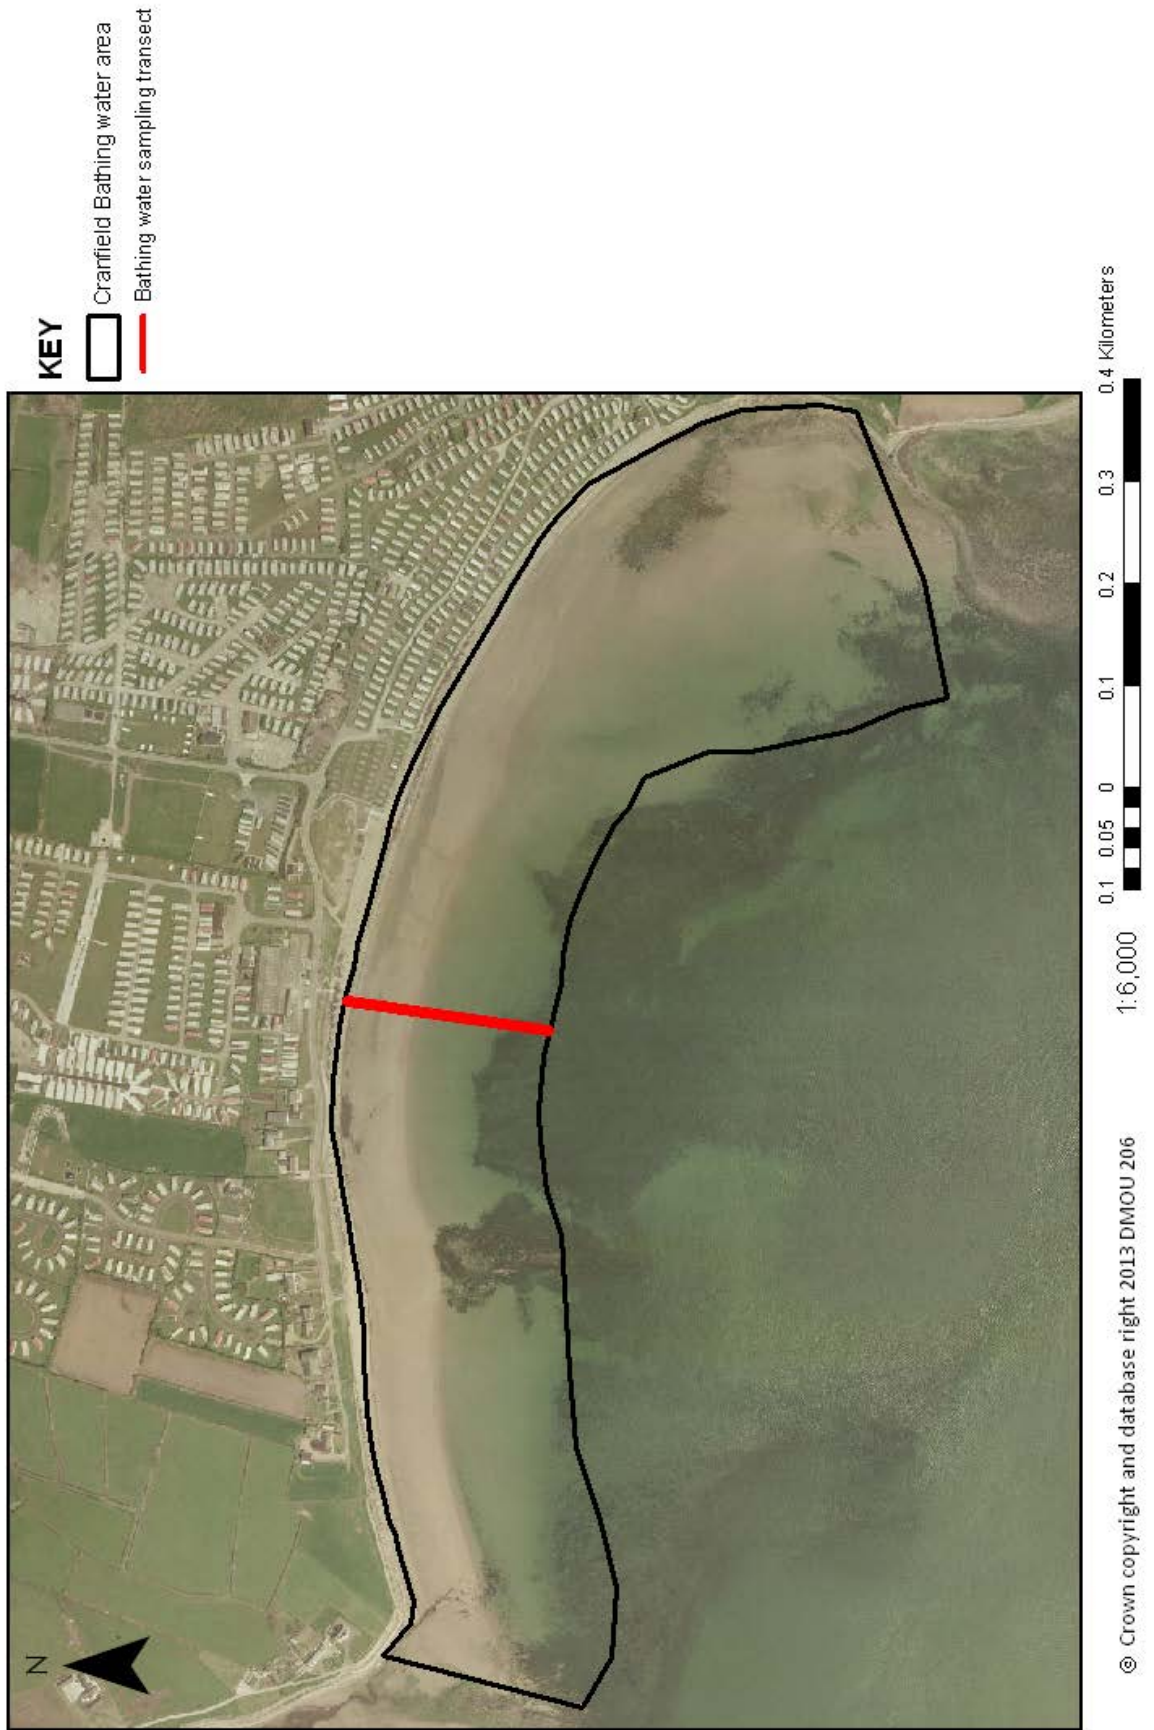
Map 2
Cranfield Bay Bathing Water -
EC Bathing Water Sample Location

Bathing Water Name	Cranfield (Cranfield Bay) Bathing Water
EU bathing water ID number	UKNO5_55600
Location	UK/Northern Ireland/County Down/South Down Coast
Year of identification	1988
Local council area	Newry, Mourne and Down District Council
Bathing Water Operator	Newry, Mourne and Down District Council
Description of bathing beach	Sand and pebbles, approximately 1.5 kilometres in length
Monitoring Point	Middle of bathing water, J26371066 (Map 2)
