Department of the Environment
Marine Division

Bathing Water Profile

Waterfoot

May 2015

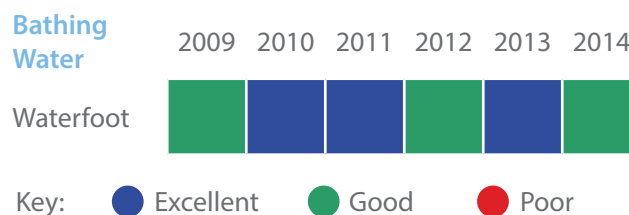
Waterfoot Bathing Water Quality 2009-2014

Waterfoot bathing water was identified in 2006. Monitoring and reporting is carried out by DOE Marine Division. Its history of compliance is displayed below and can also be viewed at www.doeni.gov.uk/marine-home
