Neagh Bann River Basin Management Plan

# Heavily Modified and Artificial Water Bodies - Neagh Bann River Basin District

December 2009

**APPENDIX IV**

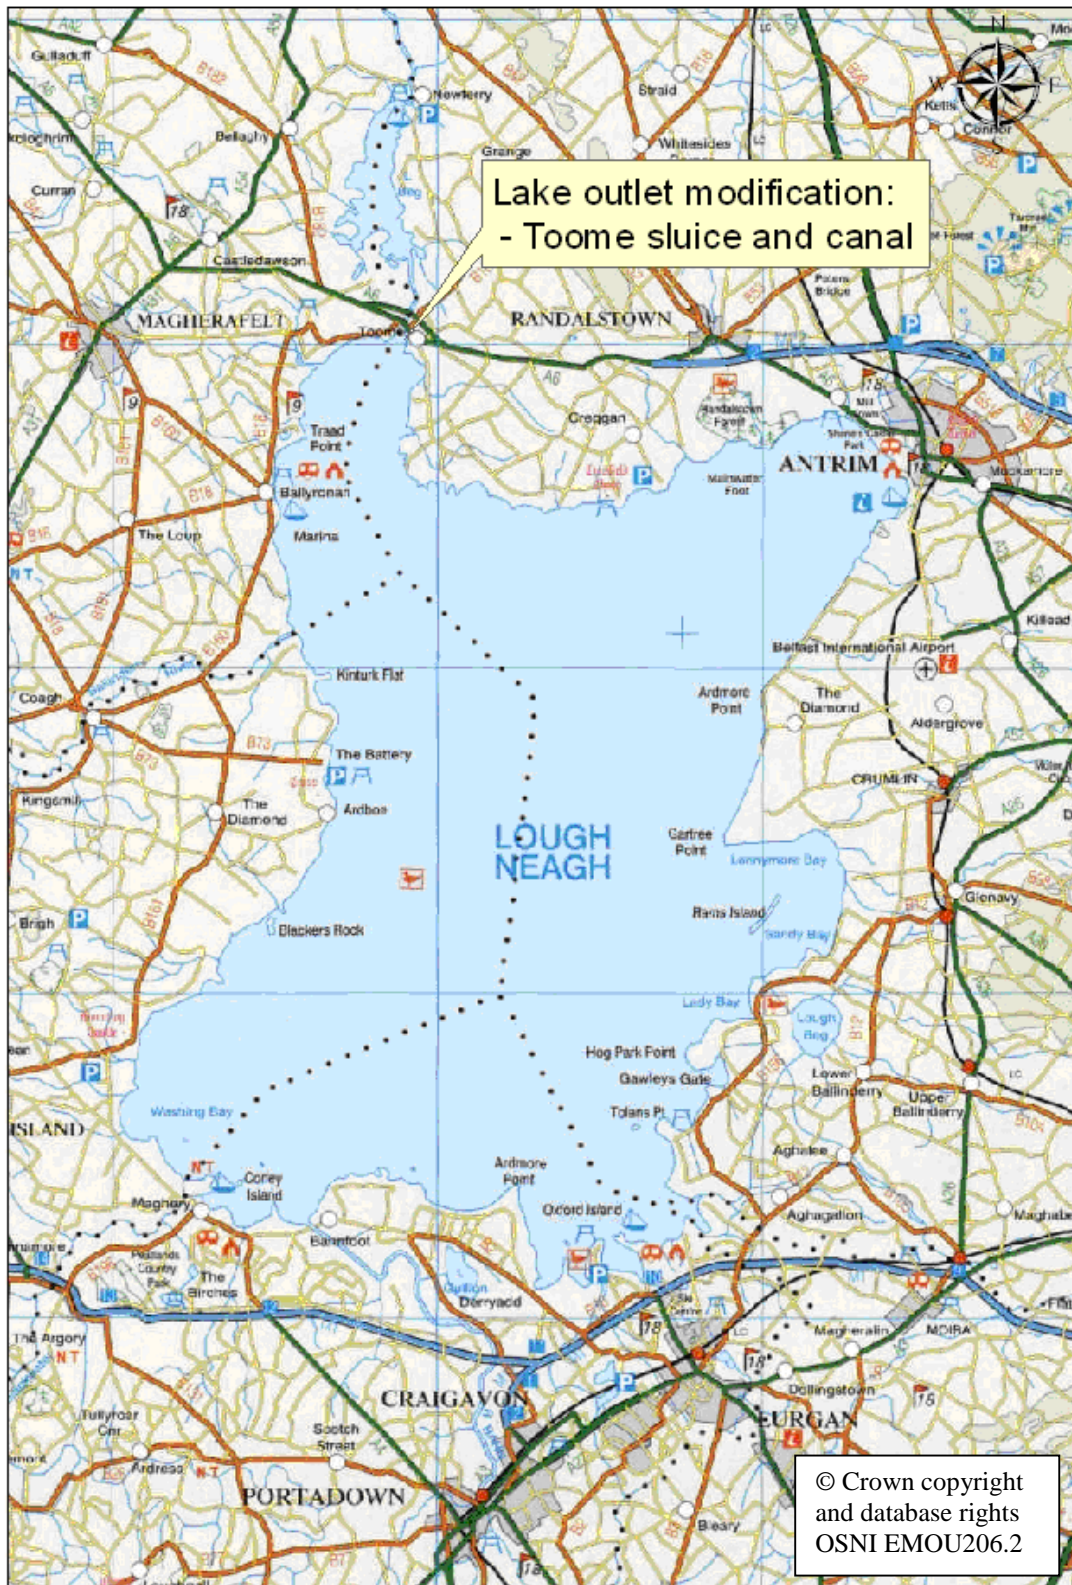
## Lough Neagh

Lough Neagh is designated as a RAMSAR site, ASSI and SPA. Lough Neagh has been lowered as part of various drainage schemes to prevent flooding of agricultural land. The net effect of this is an overall lowering of between 2-3m. The water levels are now controlled by the sluice gates at Toome and therefore the natural regime of high and low water levels no longer occurs.

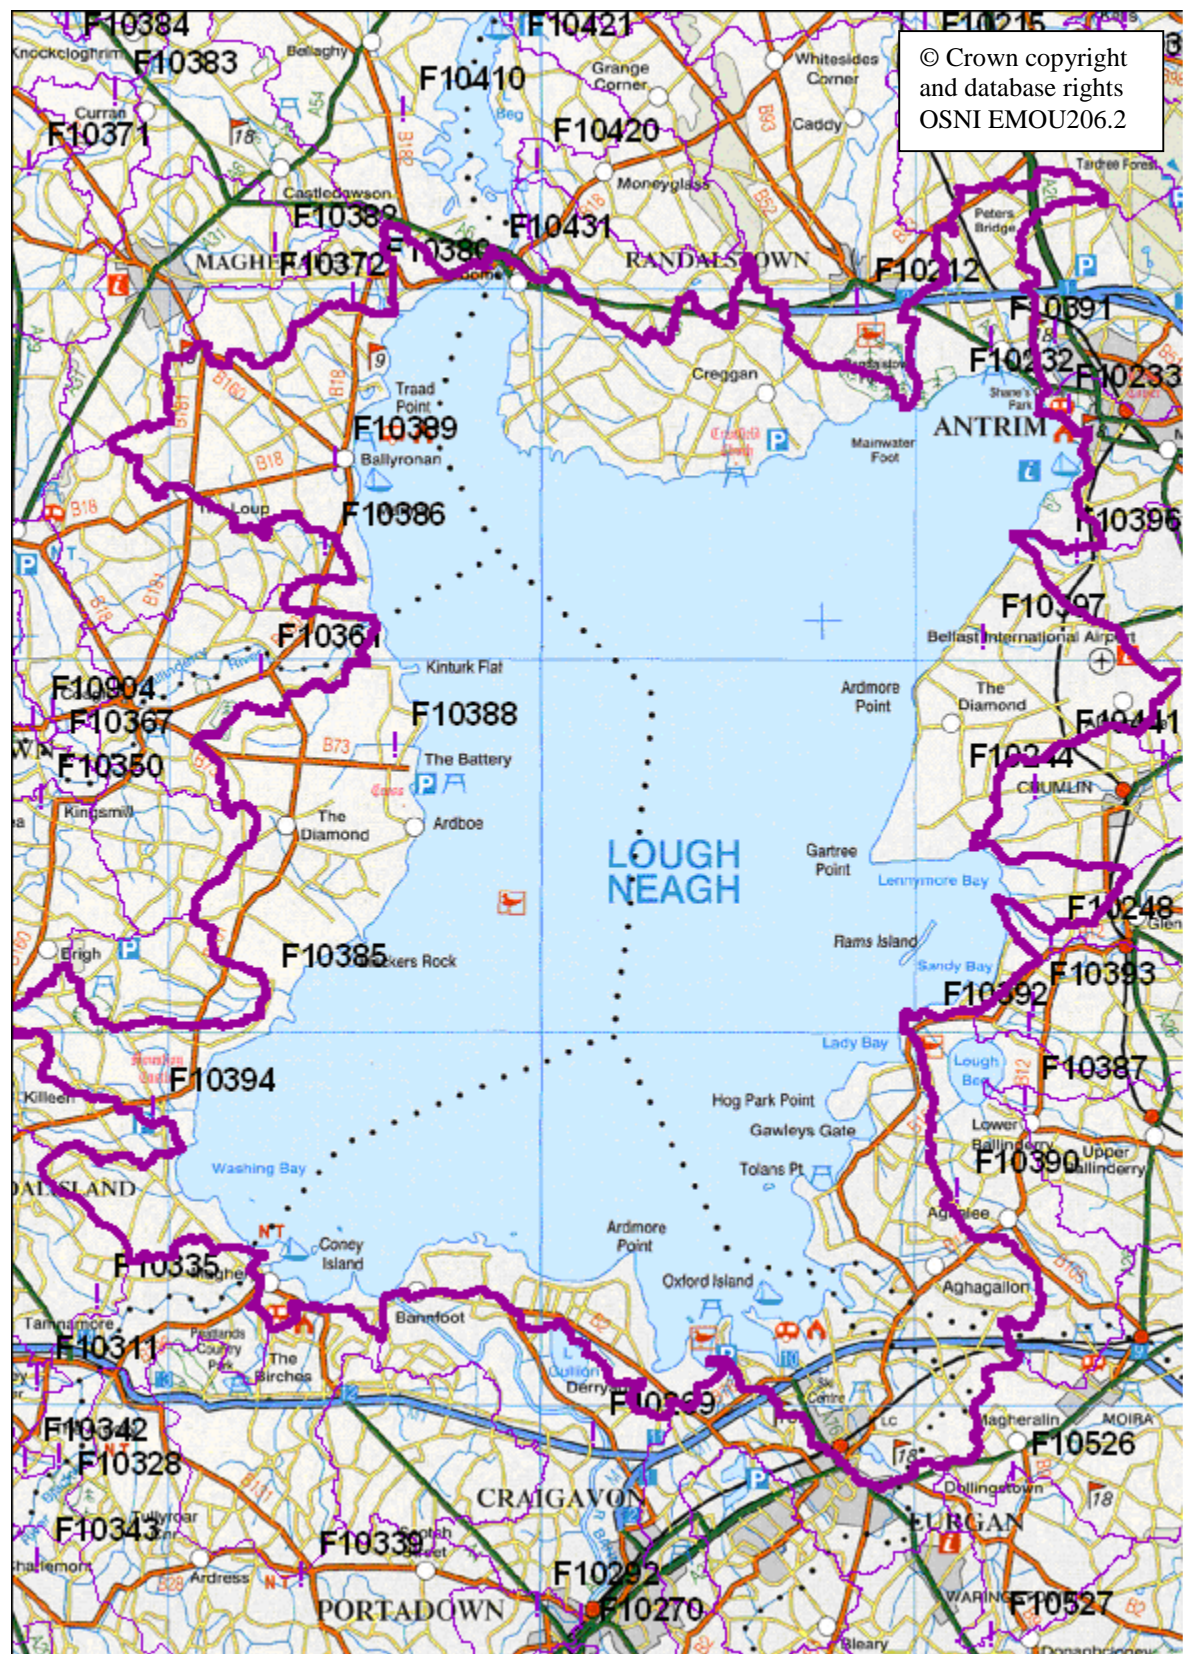
**GBN1NB030306208 - FRM**

## **Lagan Canal, Goudy River, Lough Neagh Peripherals**

A desk top study was carried out with NIEA Freshwater Monitoring and Assessment Team, The WMU hydrology team and the WMU hydromorphology team. It was assessed that in-channel, marginal and riparian habitats could be improved. The Lagan peripherals are managed to prevent flooding, so it is not known how feasible it will be to incorporate restoration measures without causing increased flood risk. Individual assessments may be required on a site by site basis.
