Bathing Water Profile

Helen's Bay

May 2019

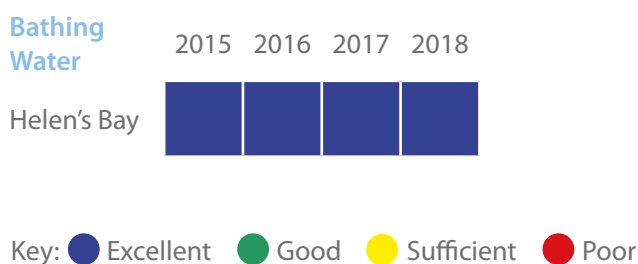
Helen's Bay Bathing Water Quality 2015-2018

In 2015 the 1976 Bathing Water Directive was replaced by the European Bathing Water Directive 2006/7/EC. This revised directive introduced more stringent bathing water standards. Bathing Waters are classified as Excellent, Good, Sufficient or Poor (see above). This classification is based on a statistical assessment of results from the last four years.
