Department of the Environment
Marine Division

Bathing Water Profile

Ballygally

May 2015

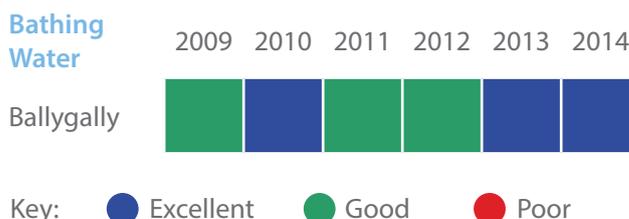
Ballygally Bathing Water Quality 2009-2014

Ballygally bathing water was identified in 2006. Monitoring and reporting is carried out by DOE Marine Division. Its history of compliance is displayed below and can also be viewed at www.doeni.gov.uk/marine-home

The 1976 Directive classified bathing waters as Excellent, Good or Poor. In 2006 a new revised Bathing Water Directive replaced the 1976 Directive. Under a new system of bacterial monitoring bathing waters will, from 2015, be judged against more stringent standards and classified as Excellent, Good, Sufficient and Poor. Using the data collated over the past years, predictions have been made of the new water quality classification and can be seen at www.doeni.gov.uk. This new system of classification will become 'live' in 2015. DOE Marine Division will continue to display both classifications up until that time, although the old classification results will be based on equivalence calculations from the new measurement methodologies, agreed at a UK level.

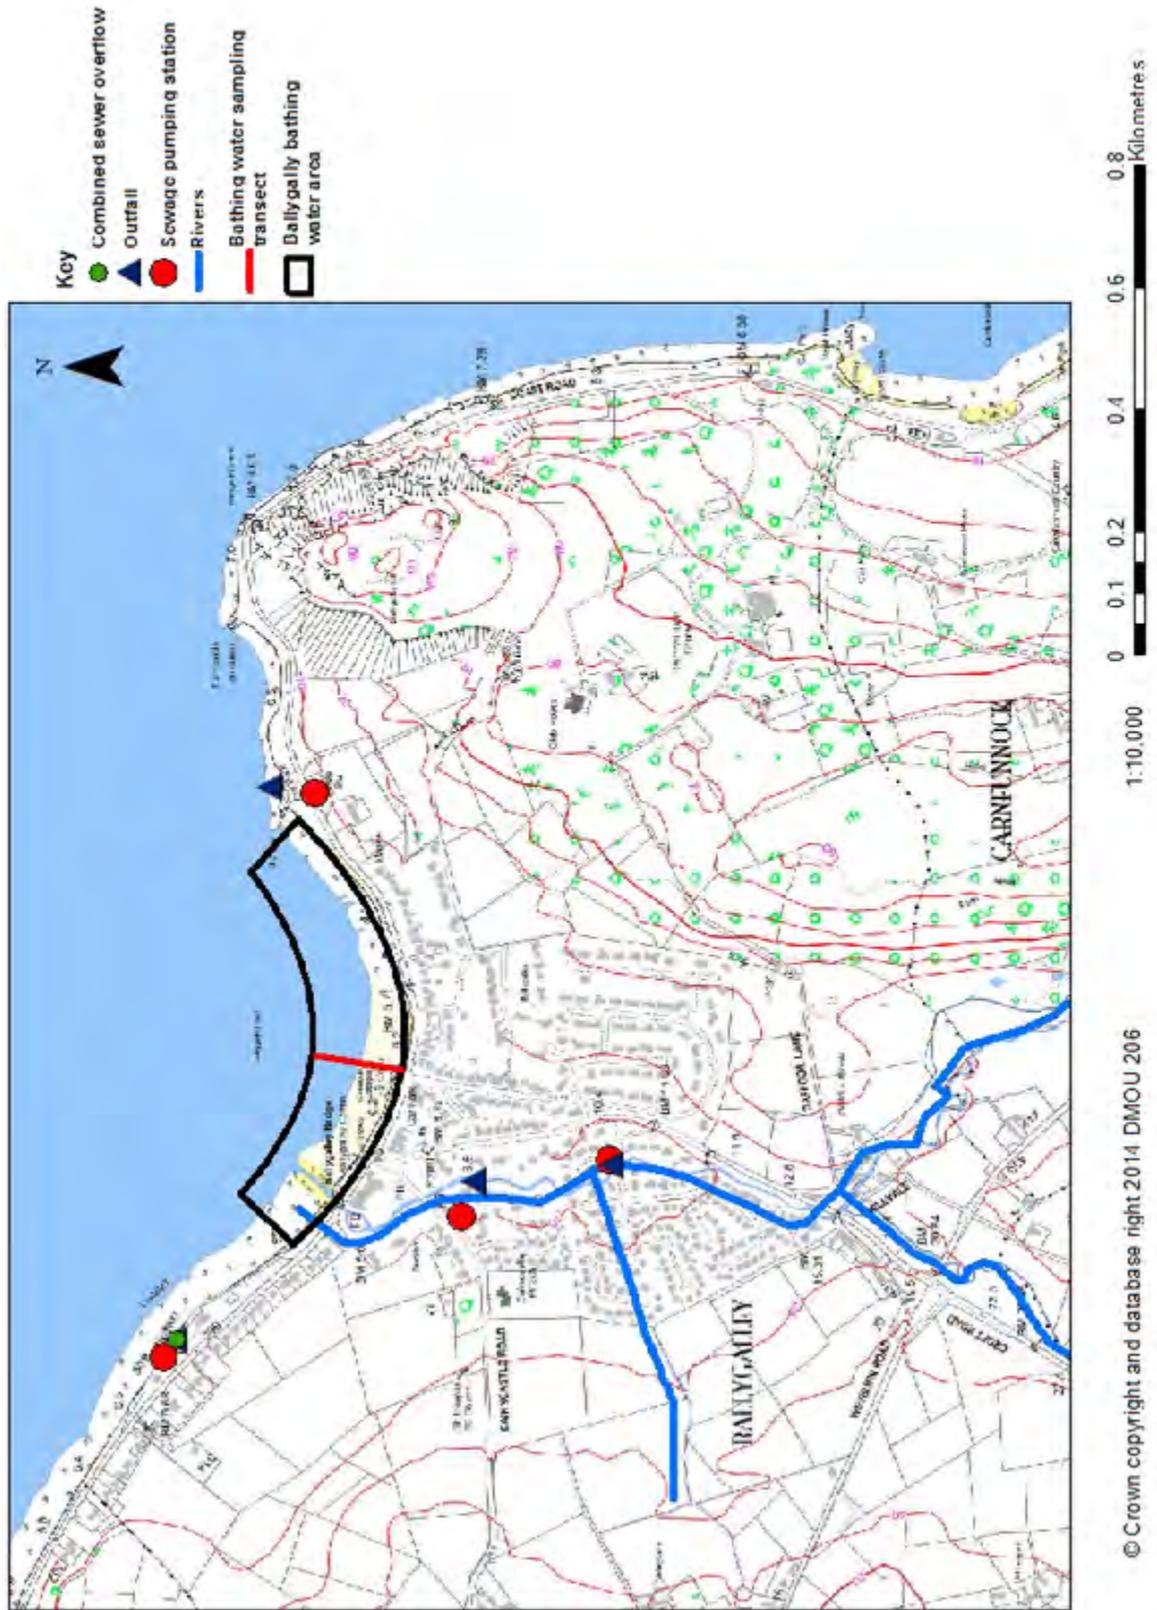
Map 1
Ballygally Bathing Water -
Potential Pollution Sources

There are no waste water treatment works in the vicinity of Ballygally bathing water (Map 1). The sea port and industrial town of Larne (approx pop 18,000) is to be found approximately 6.5 km to the south of Ballygally. A major waste water treatment facility for the greater Larne area, including Ballygally, was commissioned in 2008 with a treated effluent discharge approximately 7 km (by sea) to the south of the Ballygally bathing water. The waste water receives secondary treatment with UV disinfection throughout the year.

The municipal collection and treatment of waste water has the potential to cause pollution because all collection systems must be designed to overflow in periods of extreme wet weather or following failure of the pump system. If systems are not designed in that way, then sewers may overflow into residential areas. Within the Ballygally area there are sewage pumping stations (SPS) with associated emergency overflows as shown on Map 1.

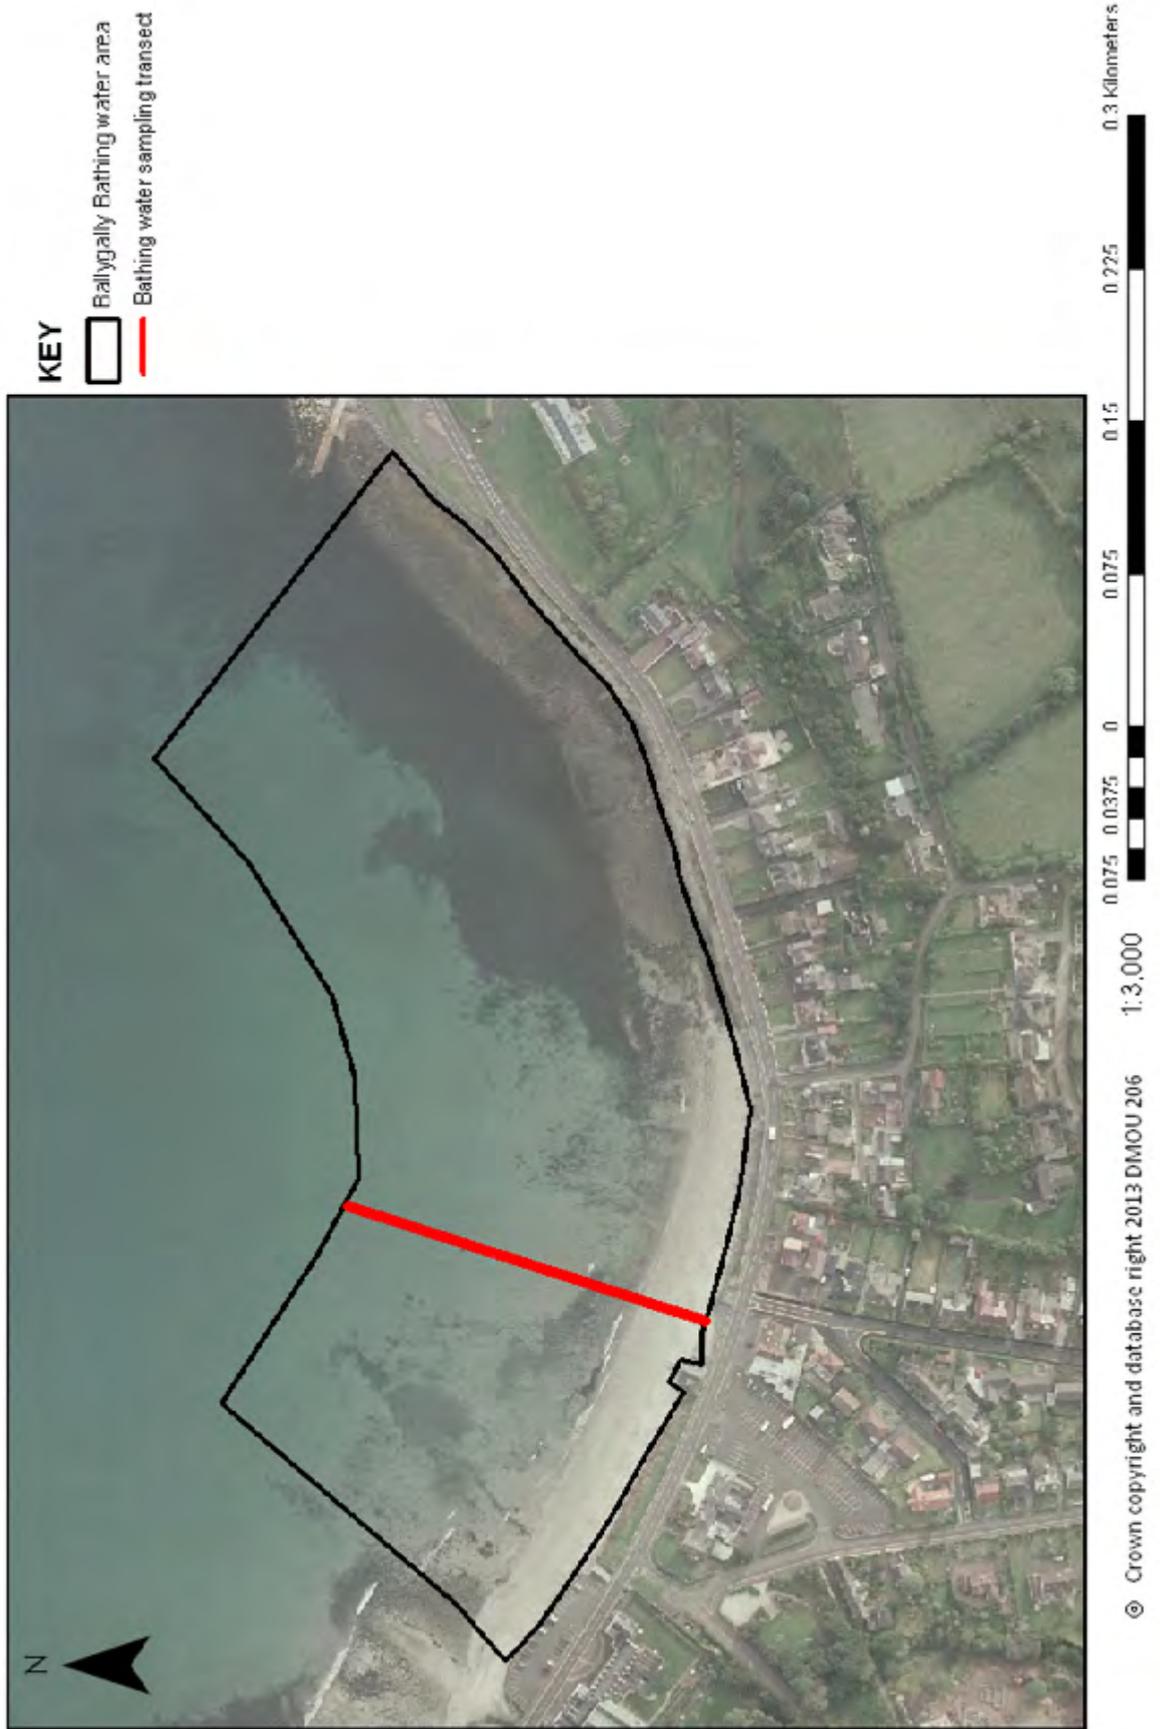
Map 2
Ballygally Bathing Water -
EC Bathing Water Sample Location

Bathing Water Name	Ballygally Bathing Water
EU bathing water ID number	UKNO5_51000
Location	UK/Northern Ireland/County Antrim/Antrim Coast
Year of identification	2006
Local council area	Mid and East Antrim Borough Council
Bathing Water Operator	Mid and East Antrim Borough Council
Description of bathing beach	Sand, approximately 0.6 kilometres in length.
Monitoring Point	Western end of bathing water, D37430781 (Map 2)
