Department of the Environment  
Marine Division

Bathing Water Profile

# Ballyholme

May 2015

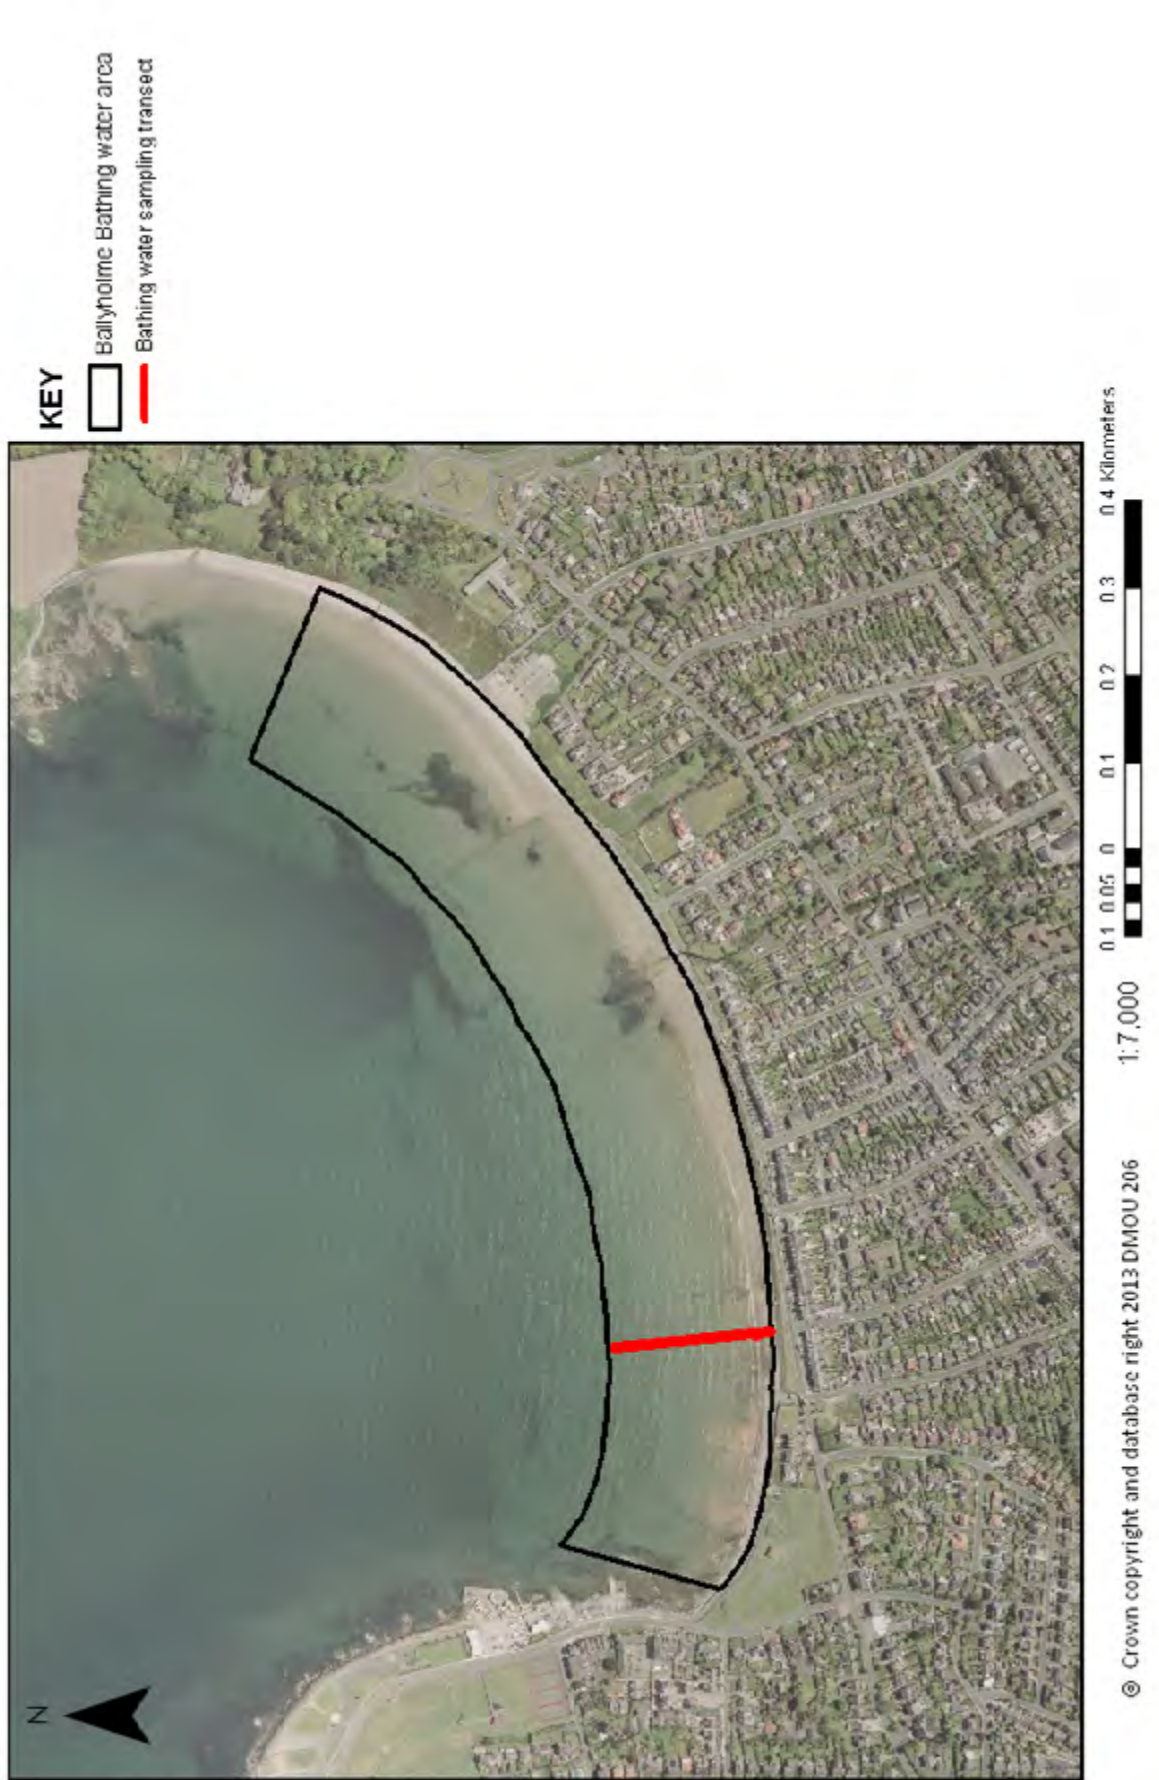
Map 2  
Ballyholme Bathing Water -  
EC Bathing Water Sample Location

<b>Bathing Water Name</b>	Ballyholme Bathing Water
<b>EU bathing water ID number</b>	UKNO2_52300
<b>Location</b>	UK/Northern Ireland/County Down/North Down Coast
<b>Year of identification</b>	1993
<b>Local council area</b>	Ards and North Down Borough Council
<b>Bathing Water Operator</b>	Ards and North Down Borough Council
<b>Description of bathing beach</b>	Sand, approximately 1.3 kilometres in length.
<b>Monitoring Point</b>	Western end of bathing water, J51788226 (Map 2)
